The Church of Holy Trinity, Lambley, Southwell Diocese
Quinquennial Survey Report 2020

QUINQUENNIAL SURVEY OF THE CHURCH OF HOLY TRINITY, LAMBLEY

To the Priest in Charge and Church Wardens of the Parish of Holy Trinity, Lambley, Nottinghamshire. An inspection of the church has been made by Mr Bruce Bradley on 3rd November 2020, commencing at 10.30 am and completion at 1.0pm

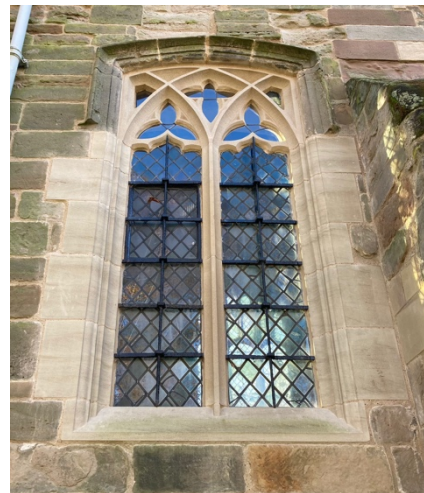
Fig 1

- a Since the last inspection the stonework to the window on the north side of the chancel has been repaired along with the glazing (Fig 1)
- b The north and east walls of the chancel have been repaired – see section D
- c A loose tower roof flashing has been re-fixed
- d The uneven tarmac footpath south of the nave has been resurfaced and an improved set of steps formed adjacent to the east wall of the chancel (Fig 2)
- e A deteriorating nave aisle carpet has been removed to allow the stone floor to breathe, and is being left without it

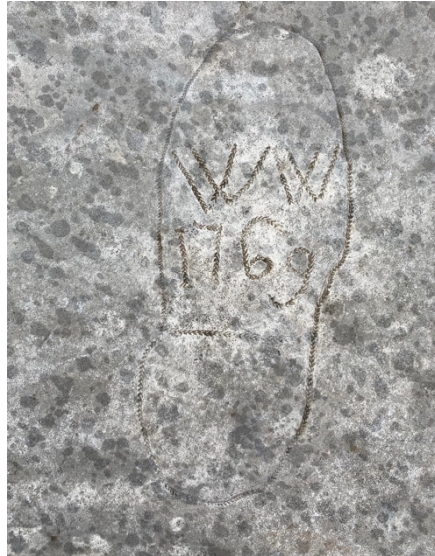
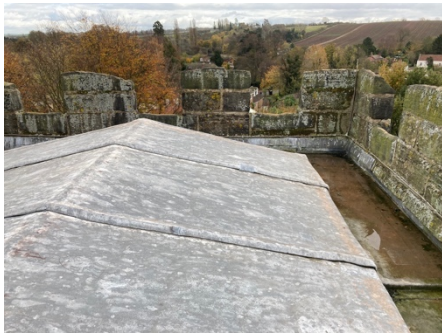
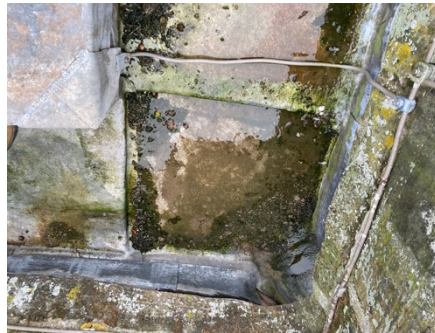
- a The lead sheets on the tower roof are late C18 (there is some graffiti of this time) see right.

Some repairs appear to have been undertaken in 1994.

The layout consists of large thick sheets with hollow rolls. There are two outlets which were clear, although the wide gutters hold some water indicating that the falls are inadequate – below right

Given its age there are very few defects and the timberwork below appears dry.

No work needed at this time.

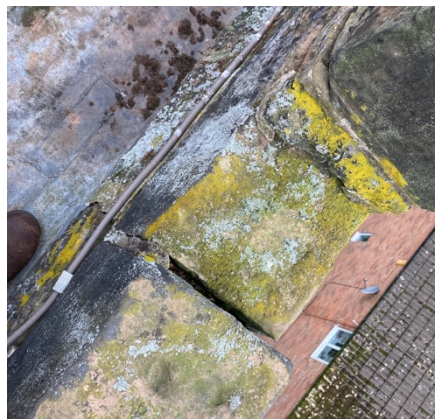
- b The parapet stonework is solid and generally well pointed however there is still one open top joint that requires repointing- right.

Open joint north side

B

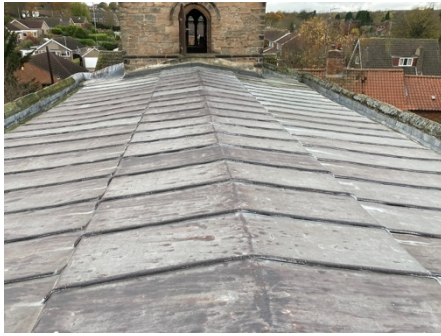
- a The roof lead work to the nave and chancel was replaced in the 1980's and incorporates rigid insulation. It consists of large sheets with very tight hollow rolls. Overall, it is in very good condition, the wall cover flashings are all in place and the gutters and outlets were clear. See below

Nave roof leadwork

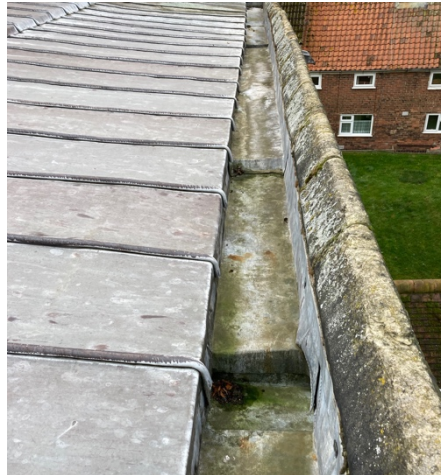
Clear, well stepped gutters

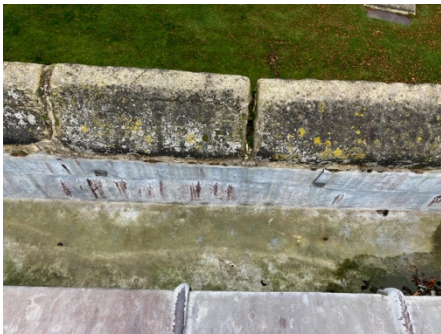
- b The lead work has a slight bow from ridge to gutter reflecting the bow in the underlying rafters.
- c The stone copings are all solid. The joints to each side of the east end cross have been raked out and repointed. There is one open top joint, on the north side – see below
- d The roof leadwork is protected by a modern alarm system – see below right

Open joint north side

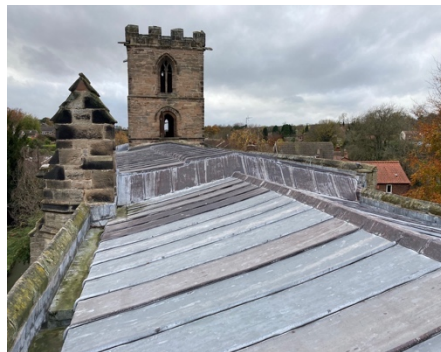
Chancel leadwork

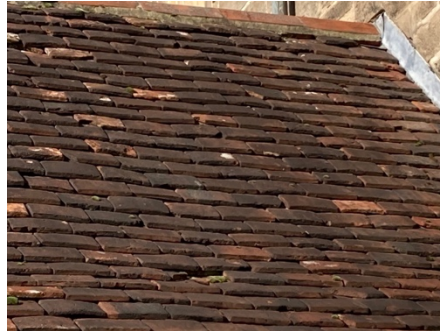
- a The roof is covered with clay tiles and there are no gutters, the tiles on the eastern slope side are older and handmade.

A few tiles have broken and need replacing. See right

B

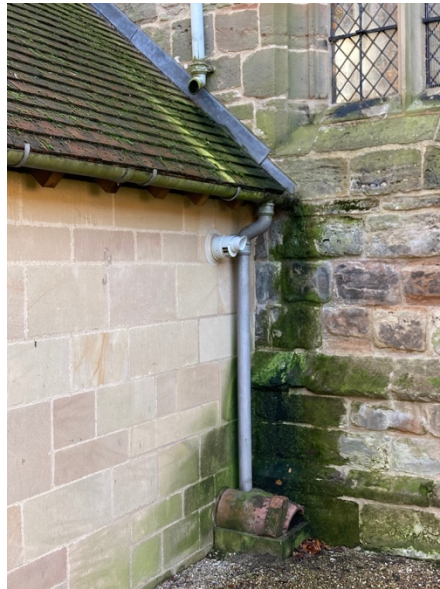
- a The tiled roof is in good condition but there is a problem with the rainwater disposal on the north side of the modern extension – see right

It appears as though the water discharging off the nave roof overloads the gutter and overflows at the outlet.

This could be resolved by rerouting/ extending the nave roof pipe down to the gully, or alternatively introducing a lead flashing at the end to prevent overspill.

The former is the more long-term solution.

A

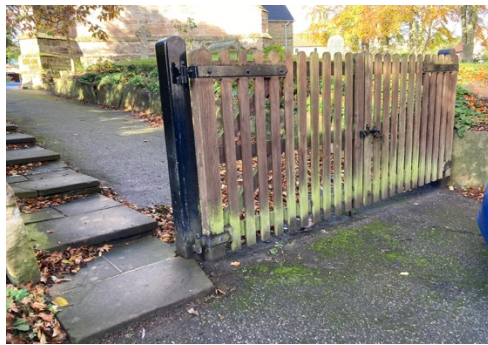
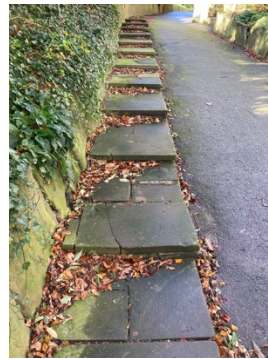
- f The oak access gates to the path are in fair condition however, brushing off the green algae build up and re treating would be beneficial (below left)

- g The approach steps are mostly sound, some minor repointing is required to the joints, see above right

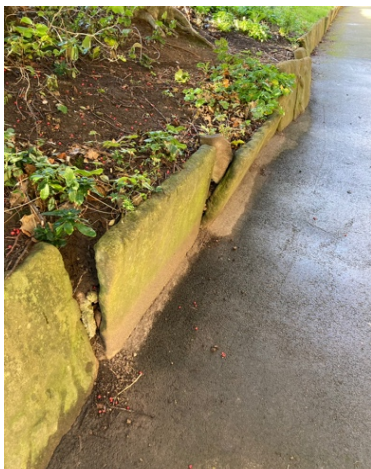
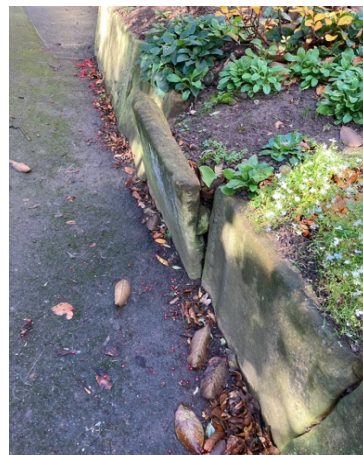
- h Stone slabs to the path support the adjacent soil at a higher level - one or two have been pushed out by the soil over time and should be monitored – see below. If they noticeably move out move further, then remedial action should be taken.

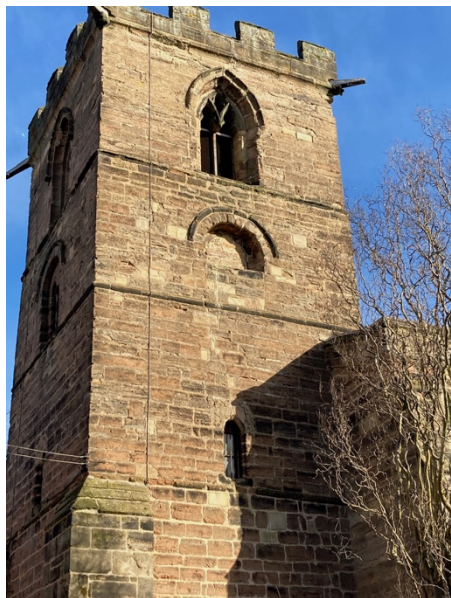
a. The lower stage has been repointed and is all sound

b. The second stage includes a C13 lancet opening and the stonework is reasonable, a few weathered back joints require repointing

c. The upper belfry stage is C14, unfortunately the central mullion is missing, and it should be re-instated based on the one on the north side.

d. Whilst the stonework is reasonable, apart from one or two eroded stones the pointing in the upper two stages is a mixture of types and qualities that would benefit from repointing.

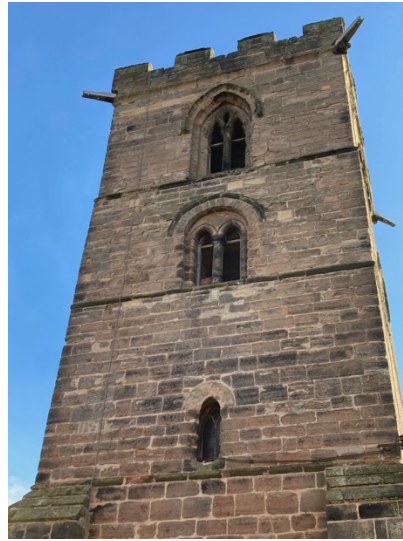
- e An attractive elevation. There is a single lancet in the second stage a lovely complete C12 semi-circular arched opening in the third stage and a C14 pointed belfry opening

Overall, the stonework on this elevation is in reasonable condition – see right, however there are a patches of unsightly mortar repairs, some thin pointing and also some eroded stones in the third stage that should be attended to

- f If work is planned for other elevations of the tower, then it would make sense to repair this at the same time

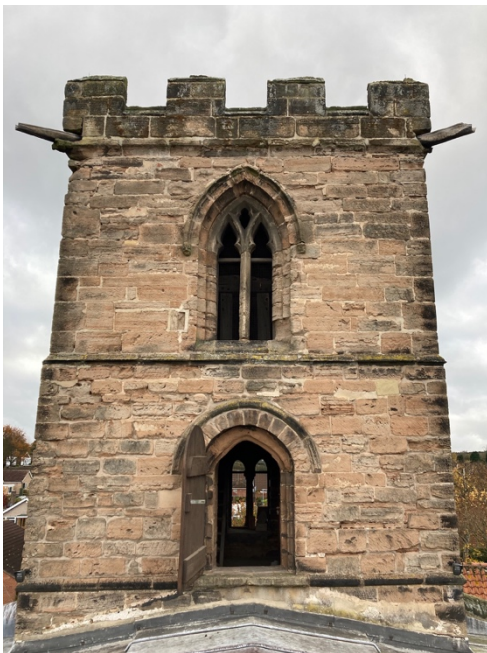
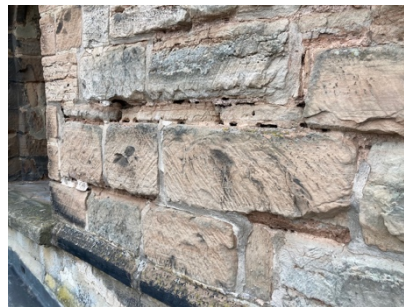
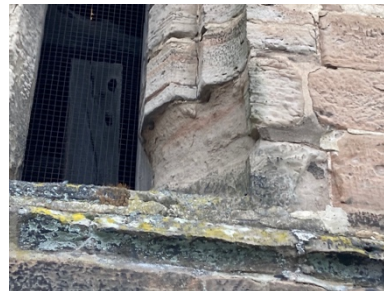
- a The walling condition on this elevation is mixed: there are patches of poor pointing, open joints and eroded stones – see above right, but mostly the stones themselves are sound.
- b At this stage the longevity of the stonework would benefit significantly from complete repointing with the repair of a few of the worst stones, including the lower right jamb stone to the belfry window – above lower right

A

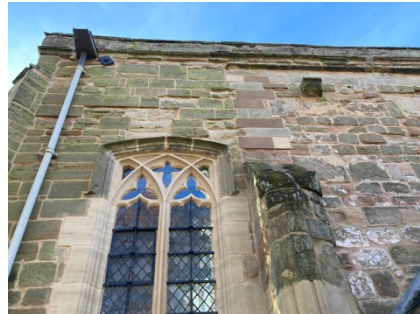
- a This elevation has been recently repaired including the buttresses and the tracery to the window, the glazing and ferramenta. See right

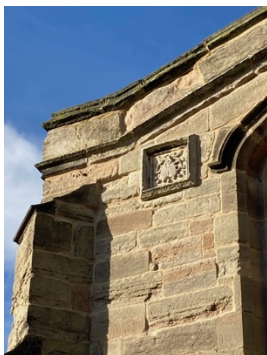
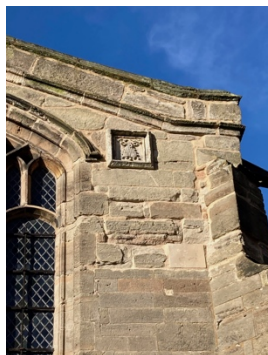
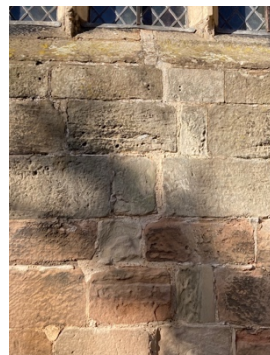
- a The Stonework and pointing at high level has been repointed as advised, and is now in better condition, see below. The historic crack below the window does not seem to have moved further since it was repointed 5 years ago.
- b The east window ferramenta is getting to the point where it should be redecorated

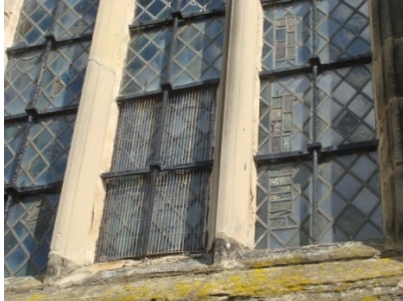
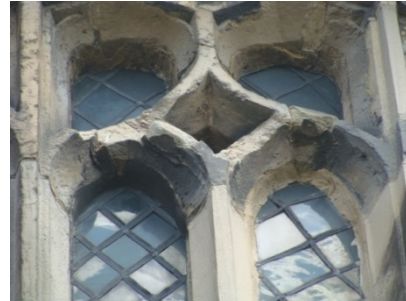
- a The elevation is in fair condition. There is one spalled tracery section to the east most window that would benefit repair and some flaunching to the lower left reveal in the centre panel that needs repointing. (see below)

B

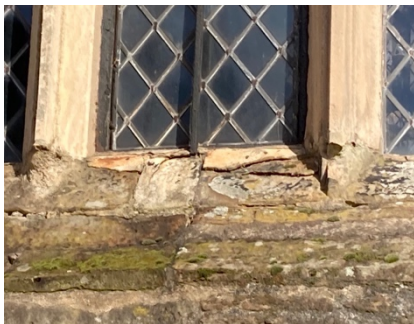
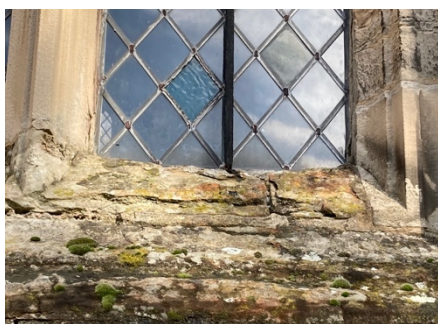
- a Most of the stonework and pointing on this elevation is in sound condition
- b Two window cills are still in poor condition and need repair (see below)

A

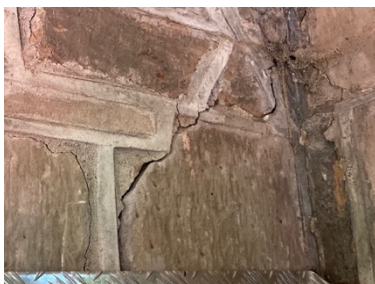
- a The whole porch has been repointed recently and is in good condition, however a crack has appeared between the front wall and the east return which should re-assessed at the next inspection. See below

R

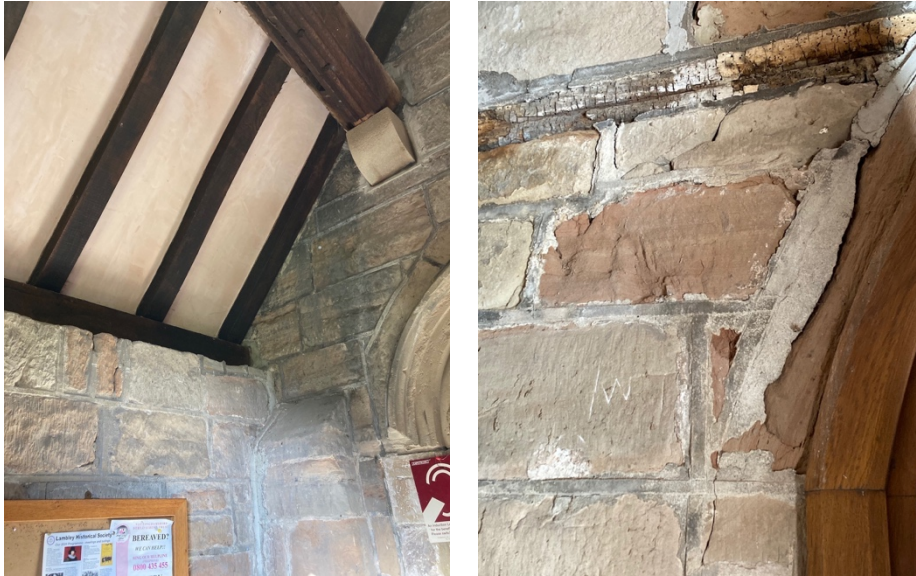
- a The porch has newish stone slabs to the floor, pointed stone walls, a roof with exposed rafters and purlins and gypsum plaster between, all are clean and sound, see below left.

- b There is cracking to each side of the external entrance door that should be re pointed to allow monitoring in case there is ongoing movement - above right **B**

- c There is also a built-in section of timber that is cubed and shows beetle holes, which should be visually monitored. Above right.

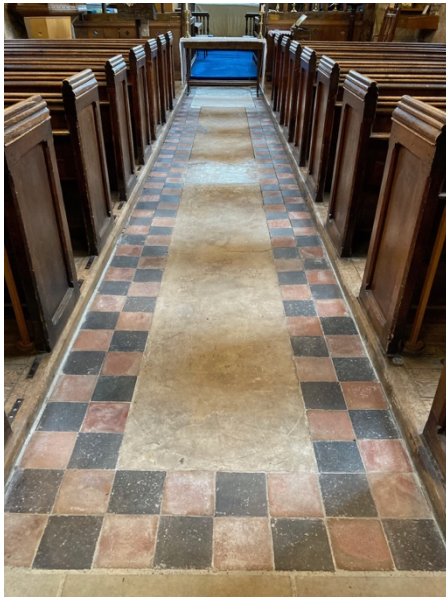
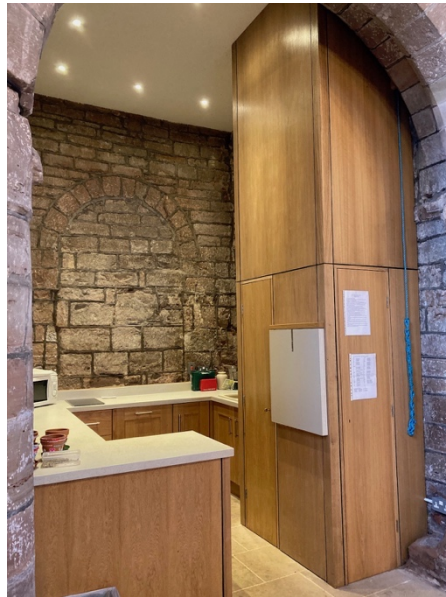
- d The central aisle carpet has been removed as it was becoming a trip hazard, this has exposed attractive black and red border tiling with central stone slabs.

The intention is to leave the floor without carpet for now and to let it breath- see below left.

- e The new kitchen area in the tower is maintained in good condition and works well – although it has not been used much in 2020 due to Covid restrictions, above right
- f The new extension lobby and toilet area are dry and clean with no defects.

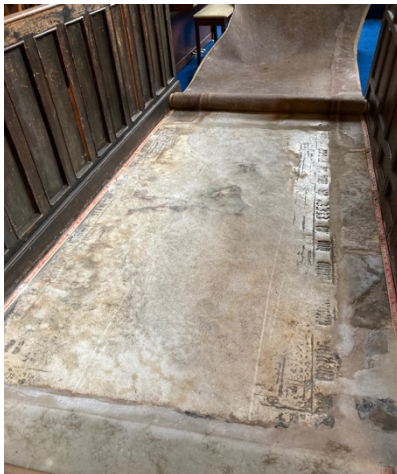
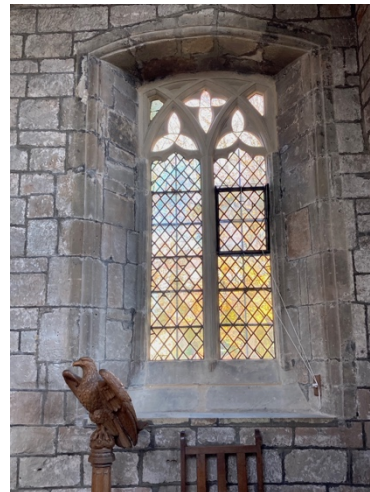
- a The stonework and pointing to walls are all in good condition. The repaired north window has been well executed – below right
- b The aisle carpet traps moisture below which causes the surface of the ledger stones to salt. The possibility of removing the carpet for a while is being considered – below left (as in many other churches)

R

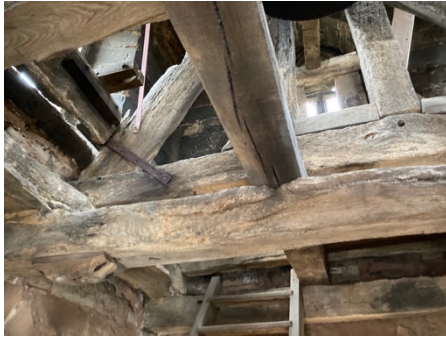
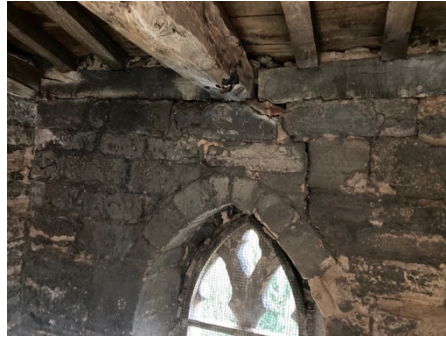
- c There is an old crack under the roof beam bearing on the north side, this should be deeply repointed and monitored. Below right

A
