**The Church of All Hallows, Gedling, Nottinghamshire**  
In the Diocese of Southwell and Nottingham

**Quinquennial Survey Report 2020**

**Surveyed under the inspection of churches measure 1955  
by Bruce P Bradley AABC.**

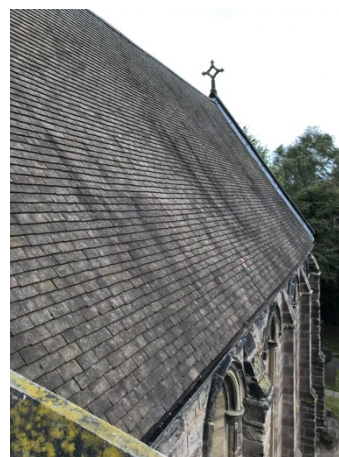
- a The chancel roof is steeply pitched and covered with dark plain clay tiles with lead abutment flashings
- b Overall, the roof and ridge tiles are fair good condition – see right

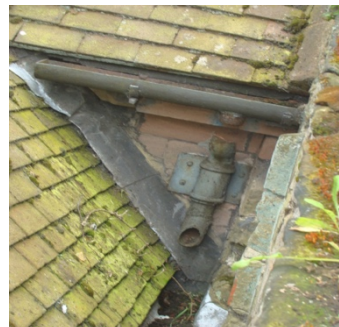
- c The gutters and down pipes are round cast iron which are in fair condition.
- d At the last inspection one short section of pipe discharging onto the valley west of the organ vestry roof was broken and needed replacing (See right). This should be repaired if not done already.

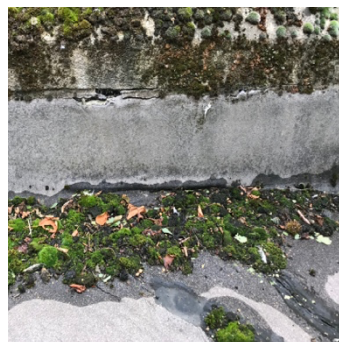
- a The vestry/office has a flat roof with asphalt finish that drains to a northeast outlet.
- b As mentioned previously the asphalt is showing signs of fatigue with many surface splits and cracked corners – see right
- c The northern wall skirting has peeled away from the brickwork leaving a gap

- d It is advised that a new roof covering is required, and I am aware that quotes have been obtained

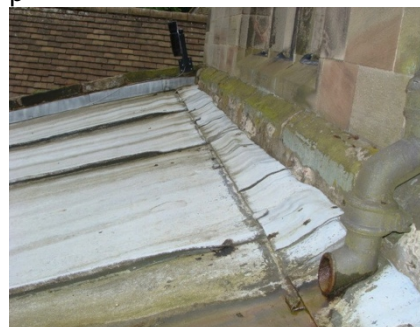
- a The roof is covered with wide old lead sheets with welted joints with little cover. Some have slipped and overlap into the gutter. A large cover flashing has been fitted at the wall abutment which is well pointed. (see right)
- b The gutter lead is laid without joints which is not to current standards in terms of steps and falls however the three outlets were clear.
- c The condition of this roof finish makes it vulnerable to water ingress. Over the longer term this roof should be one of the first to be replaced
- d Plant growth has established in joints on the eastern coping and one joint is open – attention required

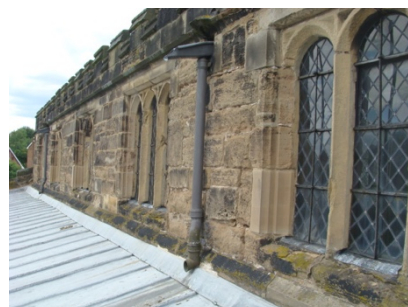
- a Covered in lead sheets laid in 1968, appears to be tightly formed hollow rolls. Some sheets stolen at the east end in 2006 were replaced in 2008. The roof is generally in good order including flashings (see right)
- b The parapet merlons appeared to be sound and the joints satisfactory
- c The outlets were clear at inspection, some light debris in the gutter from the eroding clerestory stone should be cleaned out

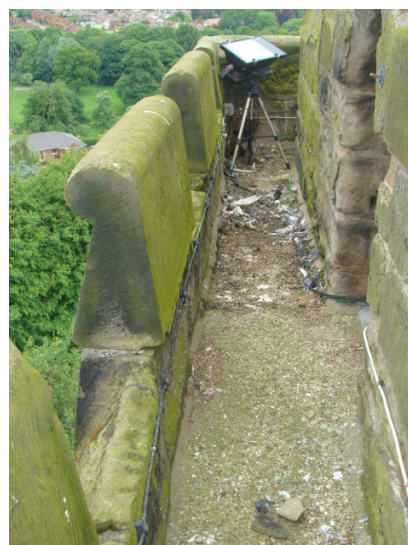
- a The narrow walkway around the tower is covered in a concrete topping laid to falls with a granular finish. It is generally sound.
- b The outlets were clear
- c The tower parapets are low but the merlons are of mostly good section and appear to be well bedded secured
- d Some small gaps noted to the wider mortar joints but no work required at present
- e As small section of loose merlon stone on the west parapet has been removed and placed on the gutter.

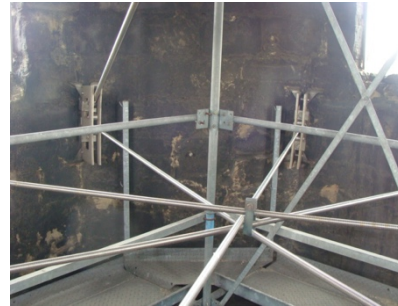
- b At my inspection the cracks were fully pointed up and there did not appear to be any new movement. the tie rods were checked and still had good tension. (see right)

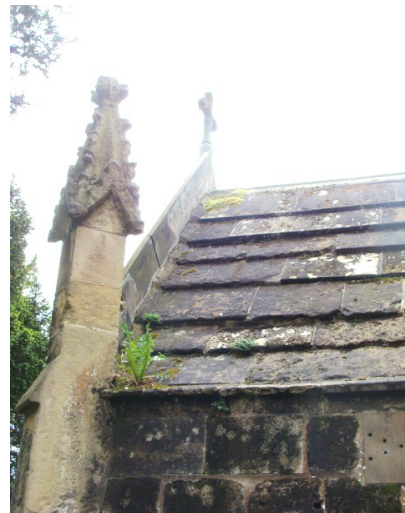
- d The lower drip course on the east side should be cleared of weed growth and repointed as necessary. (see right)

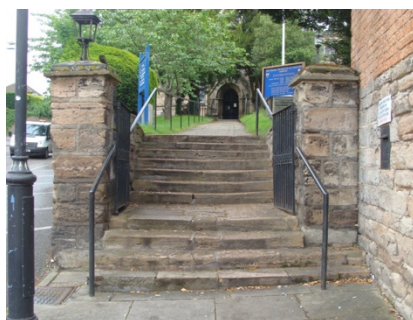
c Their condition is worn but satisfactory (see right)

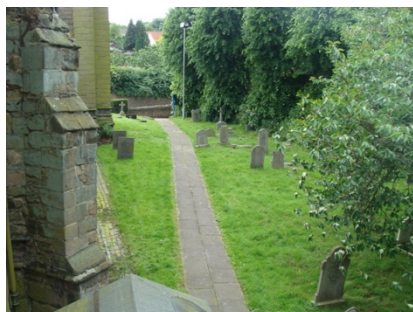
c The path is of concrete slabs in fair condition. (See right)

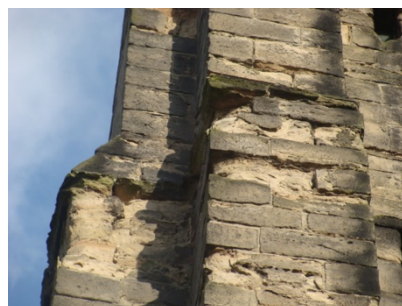
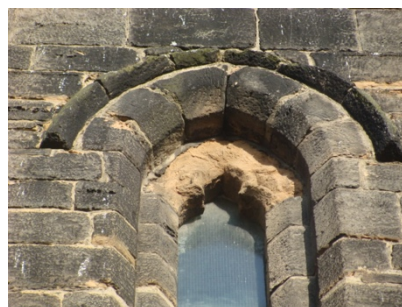
- i) The main area of walling is fair
- ii) The North buttress upper section, has around 5-6 badly eroded stones including return faces (see right)
- iii) The Southern buttress has 3-4 large stones with eroded sections
- iv) The arched head to the single lancet is heavily eroded (see right)

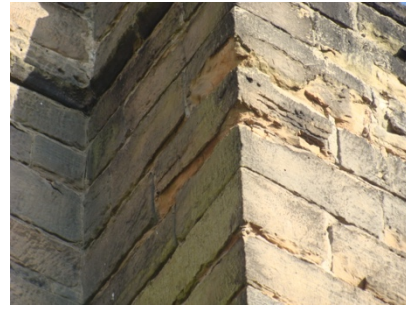
- i) The stonework and joints are fair, some erosion to lower stone edges.
- ii) The window surround and grille are sound.
- iii) Southern buttress, below set back patch of eroded face (see right)
- iv) Old fine crack below right of window

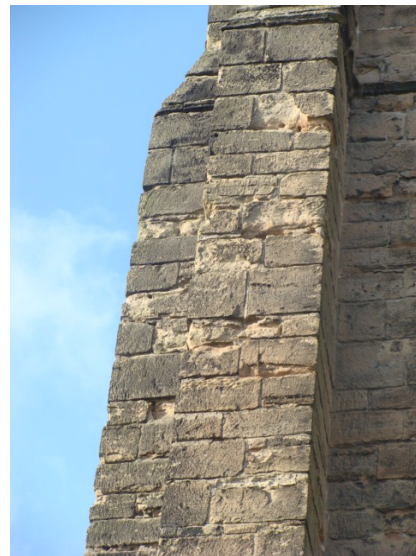
- i) Overall the stonework is fair, some eroded stone edges at string.
- ii) West buttress has 3-4 badly eroded stones in upper courses (see right)
- ii) Eastern buttress, 2 badly eroded courses below upper set back

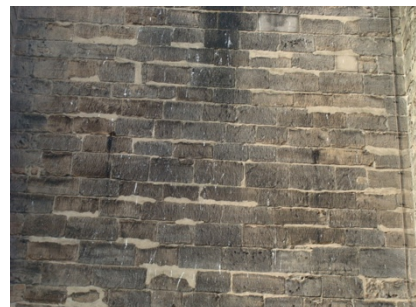
- i) Some poor mortar repairs at joints (see right)
- ii) There are a number of open narrow perpend towards the base that should be repointed

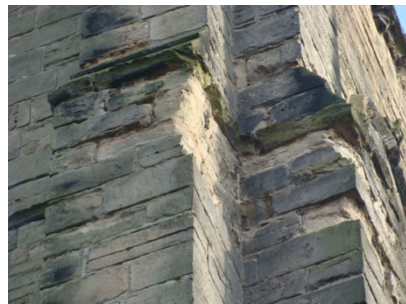
- i) Generally fair, the joint under the upper string needs repointing
- ii) 3 courses of heavily eroded to upper section western buttress(see right)
- ii) Eroded stone to inner face of eastern buttress below string.

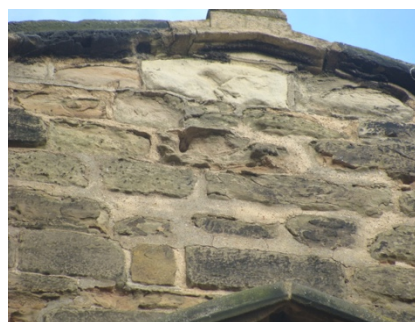
- a The pointing at high level is of mixed quality, with some loose, some proud and some open joints. (See right)
- b A few isolated stones are badly eroded.
- c It would be good to repoint and repair this elevation
- d The attractive modern west window is only partly protected by obscure polycarbonate, new grilles would be more appropriate.
- e The west door surround is fine and the oak door sound, some re-oiling/redecoration to the lower section is advised

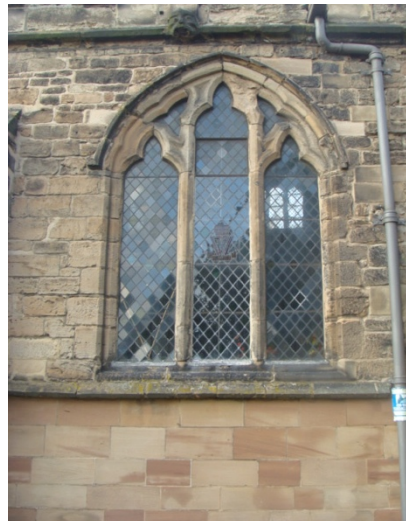
- i) The walling is generally fair, modern ashlar repairs to western edge and below string, the missing parapet pinnacle could be replaced.
- ii) One eroded parapet ashlar.
- iii) The carved eastern upper mullion stone is badly eroded and should be repaired .(see right)
- iv) The leaded glazing is of clear class, unprotected.
- v) The cast Iron rainwater pipe is sound and well decorated.

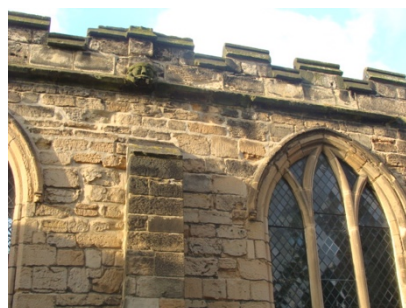
- i) Some failing pointing to parapet level, eastern bay - needs addressing.
- ii) Stonework worn and pointing of mixed quality but generally sound.
- iii) Plain window tracery; generally sound. No grilles to glazing.
- iv) The parapet pinnacles missing could be replaced (see right)
- v) There are two cast Iron rainwater pipes, they are sound and well decorated.
- vi) There is an open joint in a window mullion that requires repointing

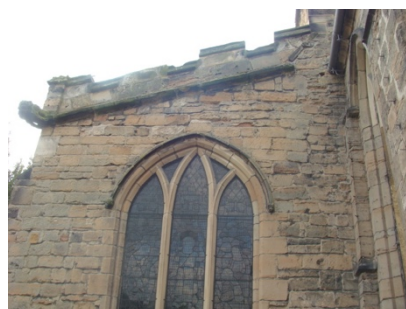
- i) The pointing below the string looks cement based and is over filled but solid
- ii) Overall the stonework and joints are fair
- iii) A coping stone is missing that should be replaced.
- iv) The corner pinnacle is missing, comment as above

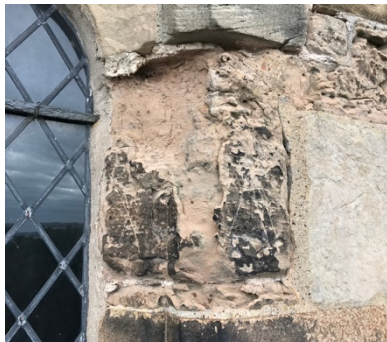
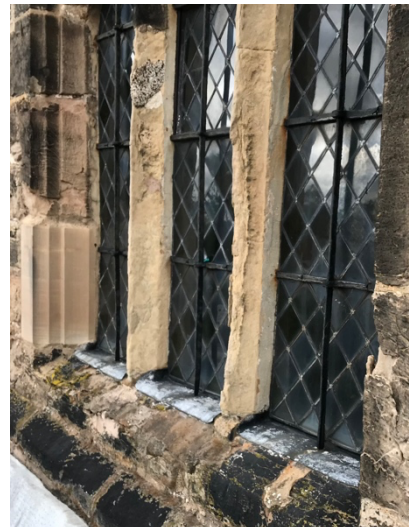
- a There are four square headed windows with triple arched panels, as noted in the previous report the window stonework is in poor condition (see right).

It is considered that eight mullions are in need of repair back to the glass line and also around ten jamb stones need replacing. (See below)

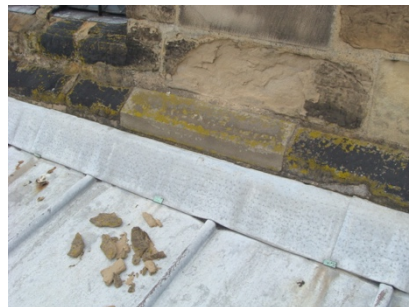
- c I have been advised that all the nave parapet merlons were removed and pinned around 10 years ago
- d A previous survey report by AJ Restoration has identified defects in the internal mullions that need repair, (one already repaired).

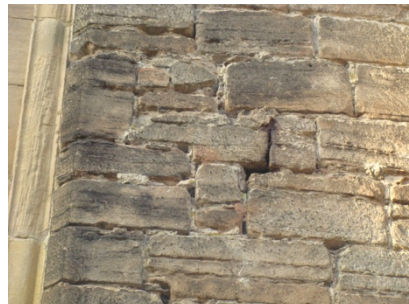
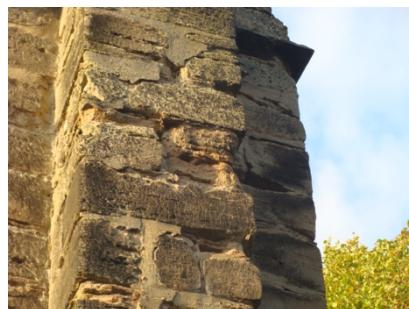
- a Repointing is required right of the eastern lancet (see right)
- b The cast iron gutter and central downpipe are sound
- c Some modern facing repairs around the lancets
- d The windows do not have grilles
- e The upper courses of the eastern buttress need some stone repair (see right)

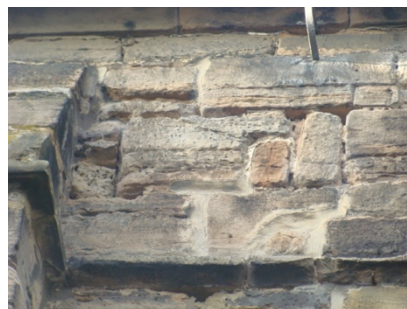
- f Isolated sections open joints below the string course in 3<sup>rd</sup> bay, also in the 2<sup>nd</sup> bay east of buttress top (see right) and also 4<sup>th</sup> bay east of lancet. (see right) need repair

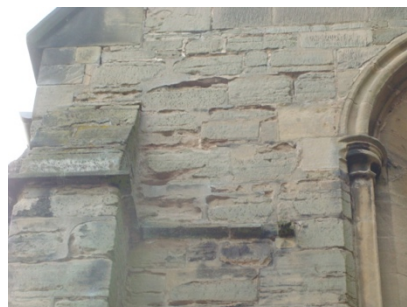
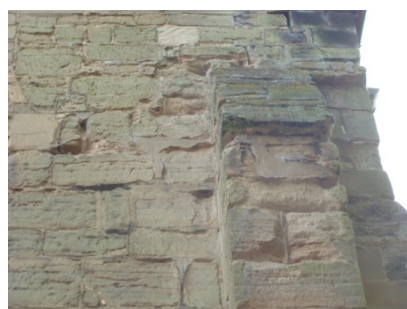
- a Large triple lancet east window in fair condition, some modern ashlar repairs to the gable over in fair condition.
- b Small patches of eroded stone to sides of west lancet top/adjacent buttress ( see right)
- c 3-4 eroded stones on upper face of north buttress (see below right) and also below lower string course
- d Also 3 or 4 eroded stone edges in lower section below string course
- e The blue brick drainage channel at the wall base is in sound condition and clear.

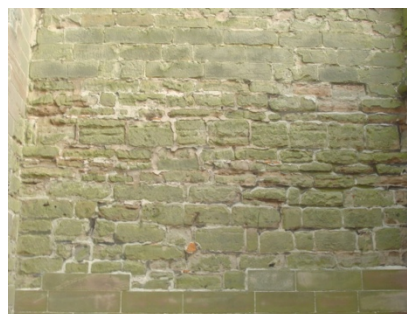
- a The stonework in the eastern bay is generally of smaller courses than elsewhere, the upper third is in fair condition.

The lower third has had ashlar repairs but there is an area of 2-3 m that requires repointing (see right)

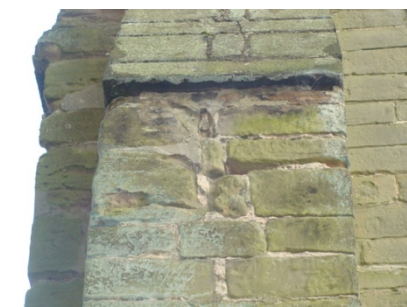
- a There are 11-12 stones with eroded sections on the east face of eastern buttress.
- b Also some heavily weathered joints on the upper north face that would benefit from repointing. (see right)
- c The walling above the vestry looks fair overall but there are some open joints and suspect pointing that should be reviewed

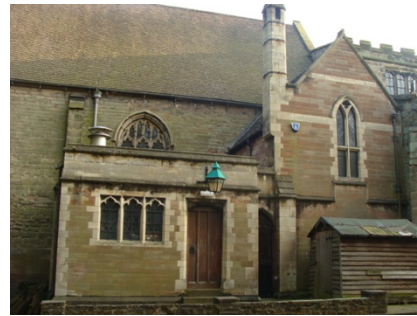
- a The stonework and windows are generally sound.
- b The chimney straps – presumably applied for structural reasons, are rusting. These could be treated and re painted but ideally would be replaced in S/S (The chimney is no longer used but is part of the external design)

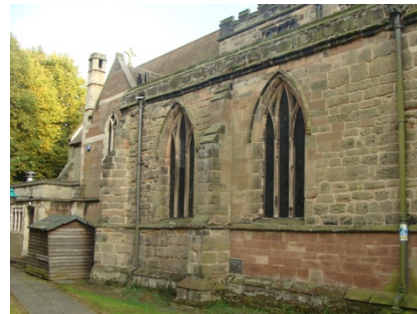
- a The older walling is generally fair, the heaviest eroded section is the west side of the western bay.
- b The parapet is plain, the upper string course has a lot of moss and one or two deeply weathered joints that require attention
- c There is substantial modern ashlar repair in the central bay in a red sandstone (see right)
- d The three tall 3 light windows have protective grilles, the glazing appears sound
- e There are three good cast iron down pipes, 2 are now connected to a new soakaway the third connects via a inspection chamber to an older soakaway that has flooded hopefully this will be alleviated now.

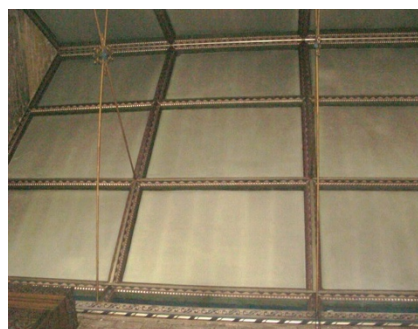
There are steel tie bars dating from 1870 (right)

The upper triangle of stone at the west end is fragile and deposits of grit fall occasionally.

- d It has been reported that grit is falling from high level at the west end of the chancel – this could be an indication of some loosening joints or friable. A closer inspection is advised if access can be arranged

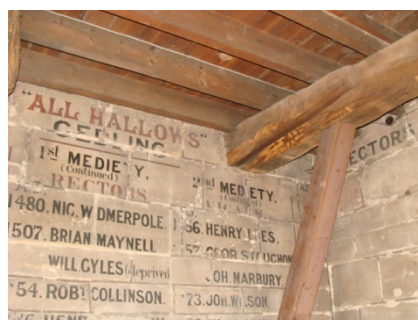
- c The ashlar walls are covered with the names of previous vicar's painted on, historic graffiti.
