The Church of Holy Trinity, Lambley, Southwell Diocese
Quinquennial Survey Report 2020

QUINQUENNIAL SURVEY OF THE CHURCH OF HOLY TRINITY, LAMBLEY

To the Priest in Charge and Church Wardens of the Parish of Holy Trinity, Lambley, Nottinghamshire. An inspection of the church has been made by Mr Bruce Bradley on 3rd November 2020, commencing at 10.30 am and completion at 1.0pm

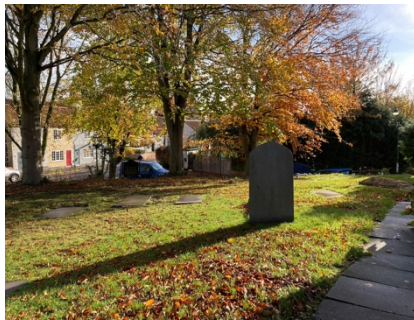
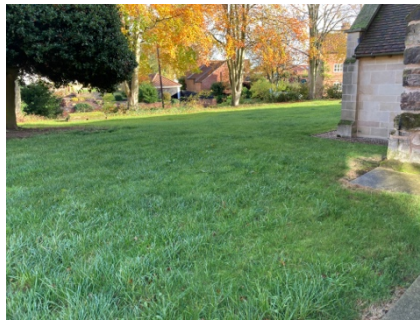
- b To the north and east the churchyard is of grass. There are one or two standing headstones stones which are stable, but most are laid flat – see below left below. The ground falls gently away from west to east and to the north, it then banks steeply down to Cocker Beck which follows Church Street. The bank contains mature trees and is covered with naturally occurring undergrowth

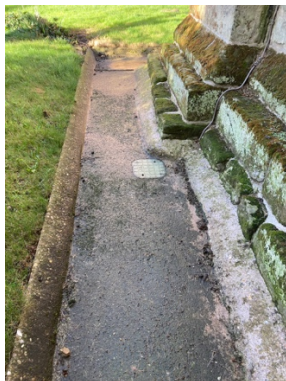
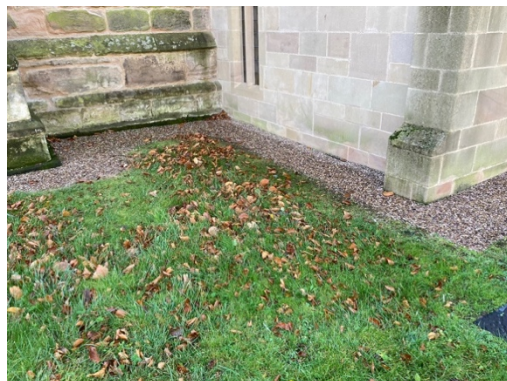
- c The landscape treatment around the walls of the church varies from a concrete drainage channel around the tower, (below left), a gravel margin to the north (below right) and the footpath to the south – all are in good condition and effective in preventing water ingress into the eternal walls.

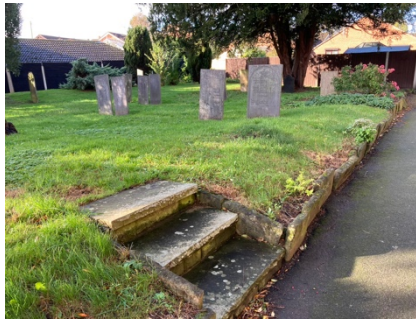
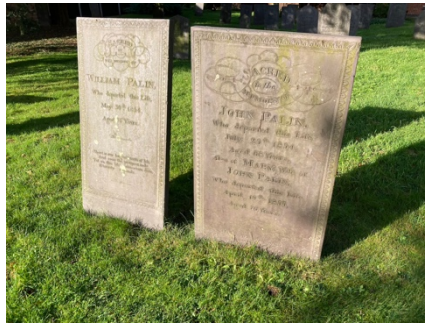
- d The churchyard south of the public footpath is raised slightly, (below left) all grassed with a mixed selection of mature trees and a range of vertical headstones, including some early C19 in slate (below right)
- e Two trees close to the church; one west of the south porch, and a magnolia adjacent the steps on the south east corner of the chancel could cause problems with the church fabric over the longer terms and should be well pruned or alternatively removed.
