**The Church of All Hallows, Gedling, Nottinghamshire**  
In the Diocese of Southwell and Nottingham

**Quinquennial Survey Report 2020**

**Surveyed under the inspection of churches measure 1955  
by Bruce P Bradley AABC.**

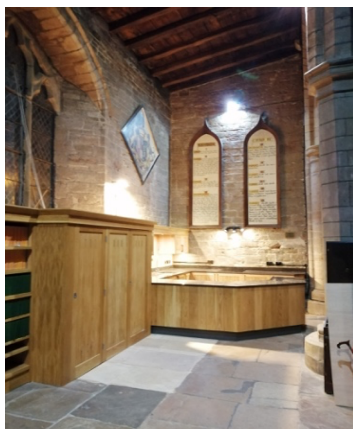
- i) Relocation and repair of mediaeval parclose screen to the east end of the south aisle
- ii) Relocation of a sarcophagus from the west end to the east end of the south aisle
- iii) Removal of the existing toilet and the formation of 2 toilets, one fully accessible along with an improved choir vestry area – below right
- iv) New foul drainage connected to the mains.
- v) The installation of a new tea bar and servery in the west end of the south aisle – see below left
- vii) New chair storage integrated into the above
